**REPORT  
OF RESEARCH  
OF ENERGY EFFICIENCY  
OF BRONYA (BRONYA WINTER)  
HEAT INSULATION**

**Thermovision inspection  
of enclosing structures**

**Residential apartment building  
in Saint-Petersburg,  
Prospekt Solidarnosti, 9/3**

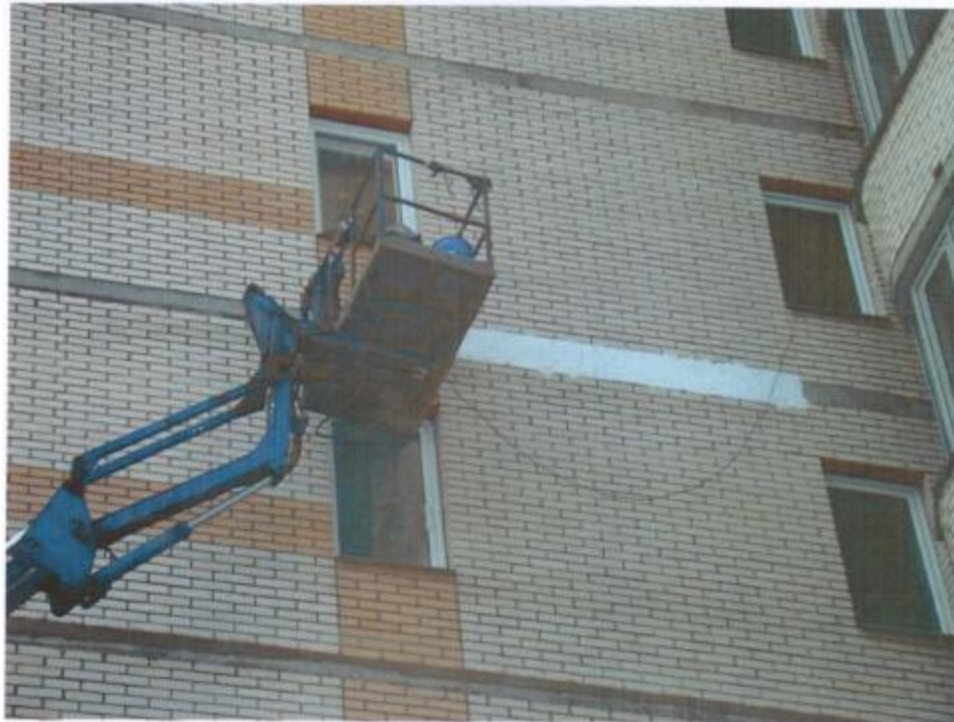
Picture 3. Application of Bronya Winter heat insulation on the butt end of a reinforced concrete floor

Additional heat insulation with application of Bronya Winter liquid heat insulation was performed in the autumn of 2013 at the temperatures close to subzero. According to the manufacturer's data Bronya Winter heat insulation consists of a composition of special acrylic polymers and foamglass microgranules dispersed in it, as well as of coloring, fire-retarding, rheological and inhibiting additives which make it possible to work at the minimum temperature of  $-30^{\circ}\text{C}$ .

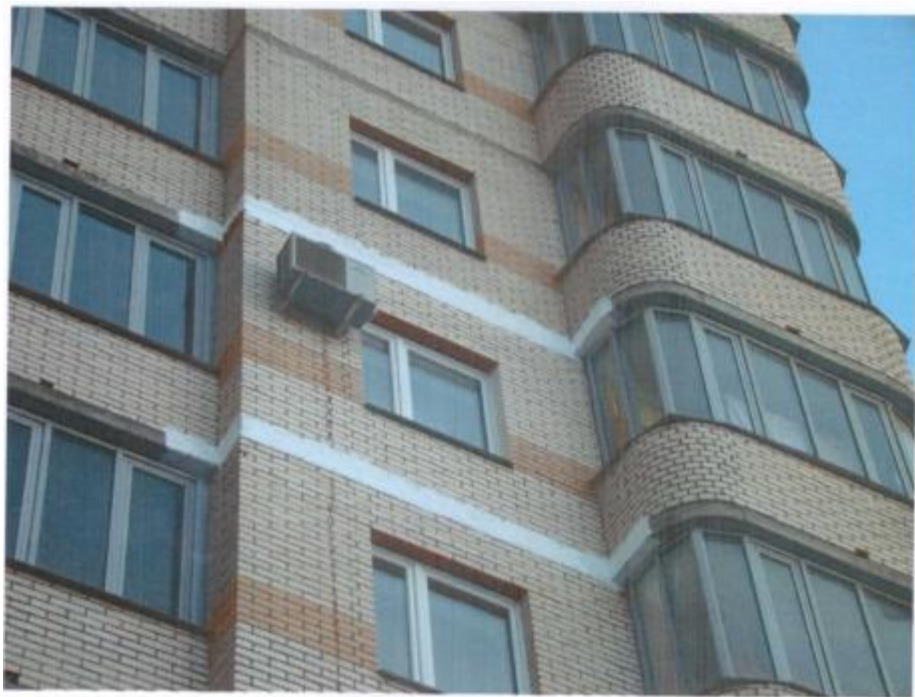
Picture 5. Fragment of the building facade with Bronya Winter heat insulation applied

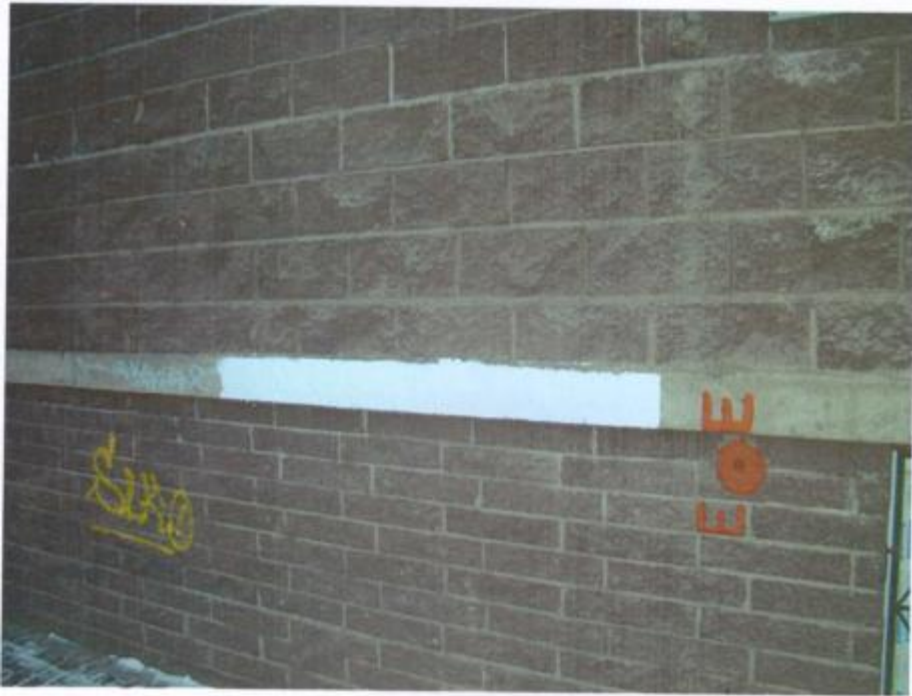
Picture 6. Fragment of the building socle with Bronya Winter heat insulation applied

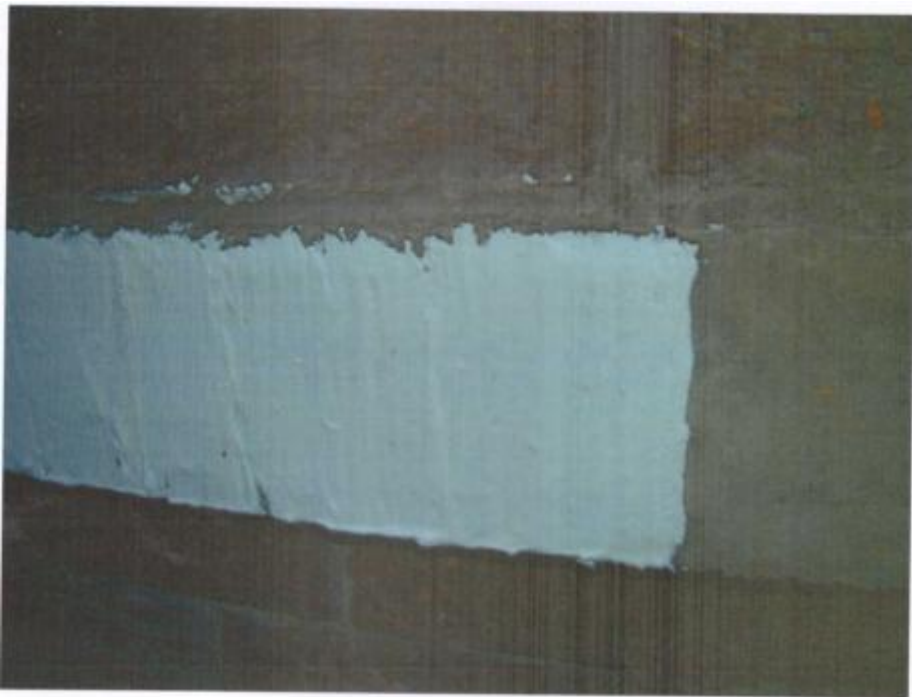
Picture 7. Fragment of the building socle with Bronya Winter heat insulation applied

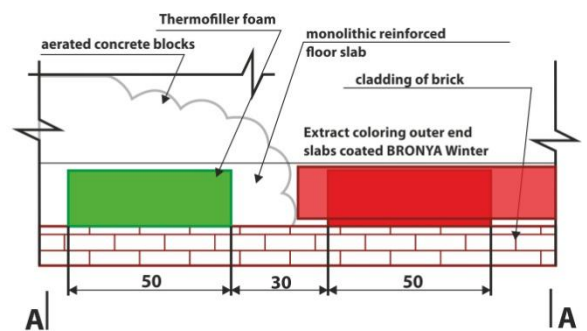
View A-A

*Thermal insert in floor slabs with coating*

*Thermogram of a fragment of outer walls and a reinforced concrete floor butt end with coating*

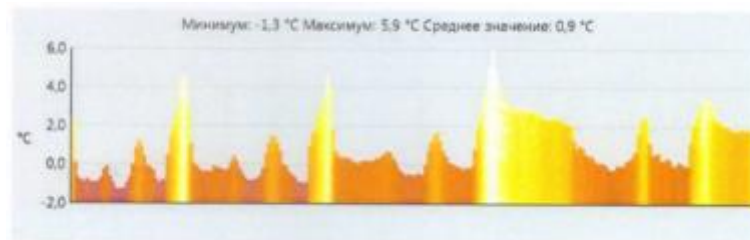
IV\_01290.BMT

## Thermogram of the enclosing structures from the outside

Ambient temperature, °C      -1.8  
Humidity, %                      64.0

Examined objects	Temperature (°C)	Emission	Reflected temp. (°C)	Notes
Measurement point 1	0.6	0.95	0.0	-
Measurement point 2	1.4	0.95	0.0	-
Measurement point 3	2.3	0.95	0.0	-

Minimum: -1.3°C Maximum: 5.9°C Average value: 0.9°C

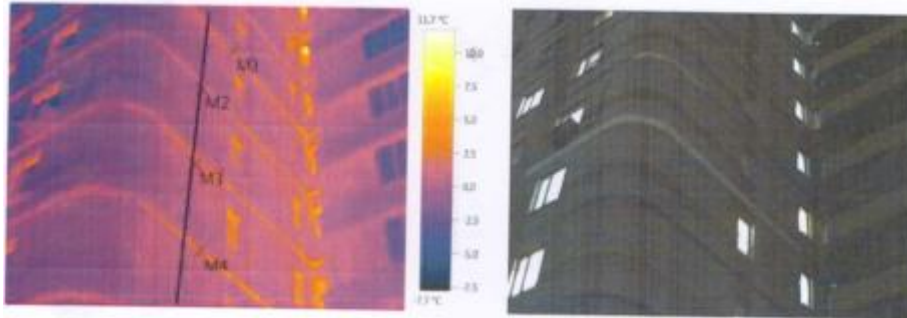
IV\_01301.BMT

## Thermogram of the enclosing structures from the outside

Ambient temperature, °C      -1.8  
Humidity, %                      64.0

Examined objects	Temperature (°C)	Emission	Reflected temp. (°C)	Notes
Measurement point 1	2.2	0.95	0.0	-
Measurement point 2	0.3	0.95	0.0	-
Measurement point 3	1.1	0.95	0.0	-
Measurement point 4	3.2	0.95	0.0	-

Minimum: -0.6°C Maximum: 3.0°C Average value: 0.4°C
